USS McINERNEY (FFG-8)

SEMAT HULL AND SUPPORTING STRUCTURE SURVEY

9/13/02- 9/18/02

PREPARED BY
SUPERVISOR OF SHIPBUILDING
CONVERSION AND REPAIR
PORTSMOUTH VIRGINIA

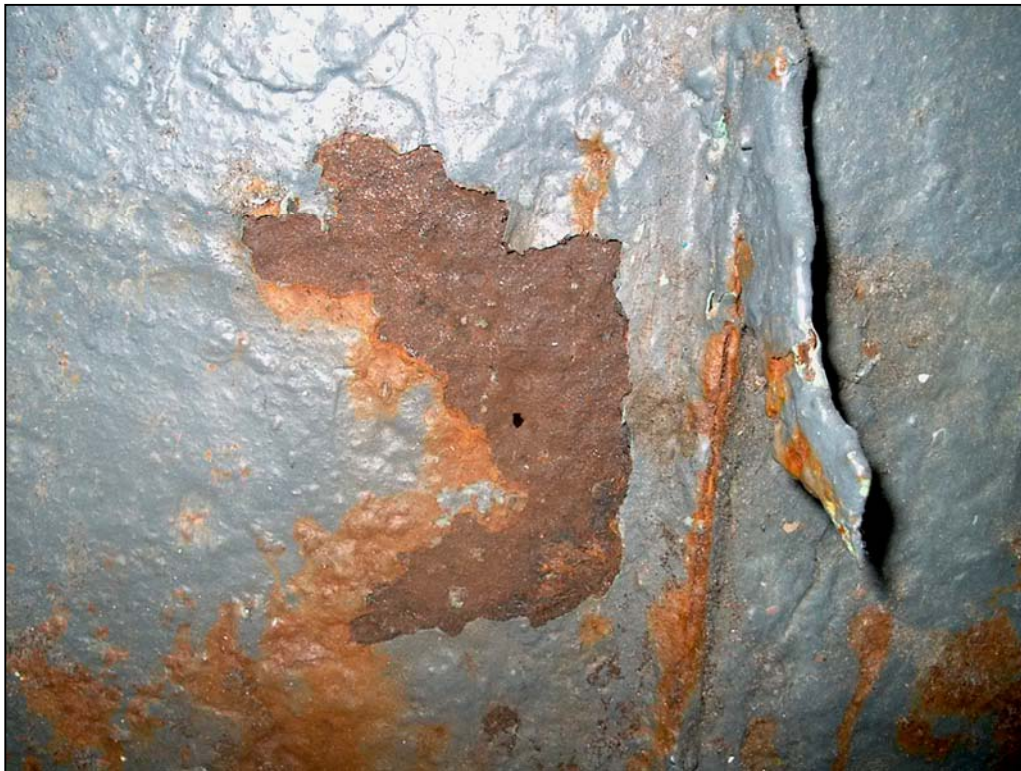
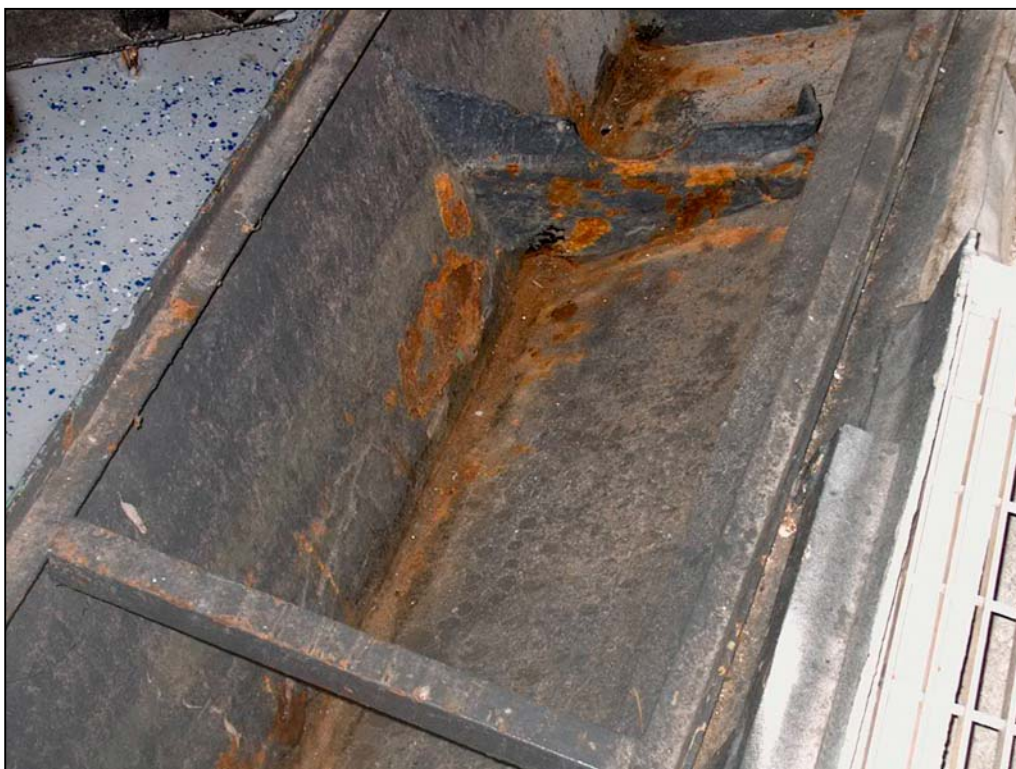
**USS MCINERNEY (FFG-8)
LAUNDRY (4-140-0-Q)**

THE MOST CRITICAL AREA NOTED WAS THE DETERIORATED MARGIN PLATE IN THE LAUNDRY. ALL CRITICAL INSPECTION AREAS WERE TESTED USING ULTRA-SONIC THICKNESS GUAGING. THE FOLLOWING PICTURE PAGES, DRAWINGS AND MATERIAL ASSESSMENT FORMS ARE THE RESULTS OF THIS SURVEY.

HOLE IN THE MARGIN PLATE (TANK SIDE 5-140-2-F) APPROXIMATELY 1FT AFT OF FRAME 156. U/T READINGS REVEALED THE MARGIN PLATE IS THINNED BELOW THE 25% WASTAGE ALLOWANCE FROM FRAMES 148 TO 160.

SAFETY HAZARD: 1. SERIOUS - CORRECT AS SOON AS POSSIBLE 2. SERIOUS - SUSPENSION OF EQUIPMENT/SYSTEM/SPACE REQUIRED 3. SERIOUS - WAIVER OF EQUIPMENT/SYSTEM 4. SAFETY ITEM - MINOR 5. COMBUSTIBLE MATERIAL		1. MAINTENANCE ACTION COMPLETED: PARTS DRAWN FROM SUPPLY 2. MAINTENANCE ACTION COMPLETED: REQUIRED PARTS NOT DRAWN FROM SUPPLY 3. MAINTENANCE ACTION COMPLETED: NO PARTS REQUIRED 4. CANCELLED - DEFERRAL WILL BE REMOVED FROM CSMP 7. MAINTENANCE ACTION COMPLETED: 3-M CAPABILITY UTILIZED 0. NONE OF THE ABOVE, DESCRIBE IN REMARKS/DESCRIPTION SECTION			1. MANDATORY 2. ESSENTIAL 3. HIGHLY DESIRABLE 4. DESIRABLE 2
DISCREPANCY DESCRIPTION: PER SEMAT UNDERWATER HULL ASSESSMENT: LAUNDRY(4-140-0-Q) AND LAUNDRY STOREROOM (4-140-2-A) MARGIN PLATE IS HOLED AND SEVERELY DETERIORATED (TANK SIDE 5-140-2-F)					
RECOMMENDED REPAIRS: DE- FUEL, GAS FREE AND CLEAN TANK (5-140-2-F), CROP OUT AND INSERT A 1'X 7' PIECE OF .250 OS PLATE BETWEEN FRAMES 156& 163,AND FROM 1FT FWD OF FRAME 148 TO FRAME 156 .APPROX 16 LFTOTAL. PERFORM NDT ON TANK.PRIME AND PAINT ALL AREAS DISTURBED BY REPAIRS.

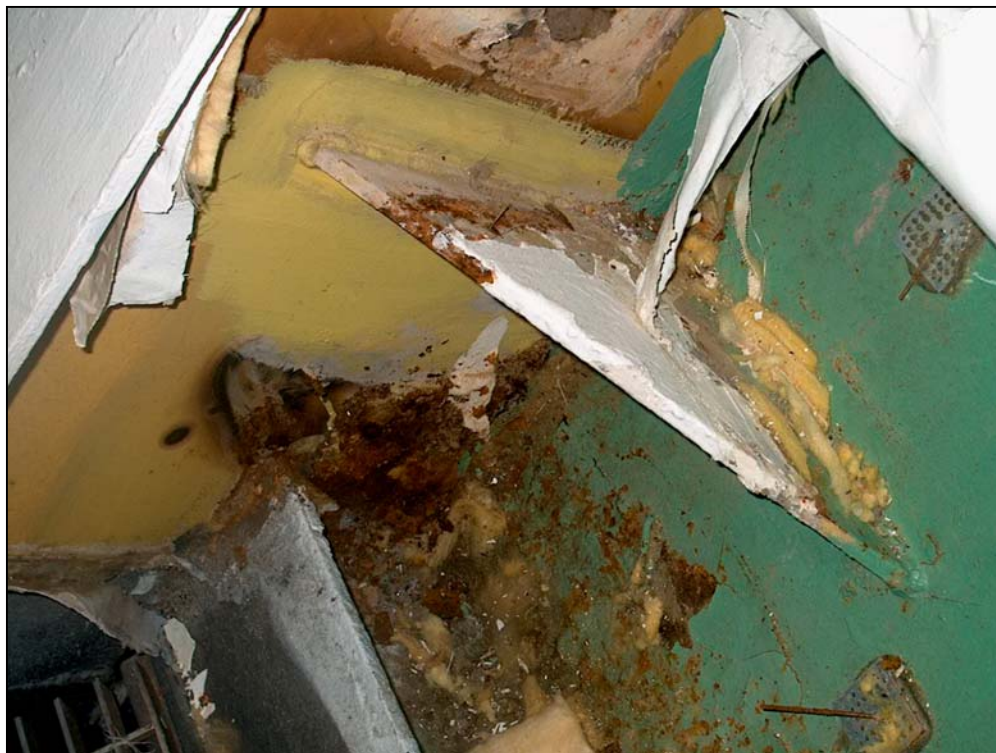
CORROSION ON THE SHELL AT FRAME 156. INSULATION IS HIDING CORROSION.

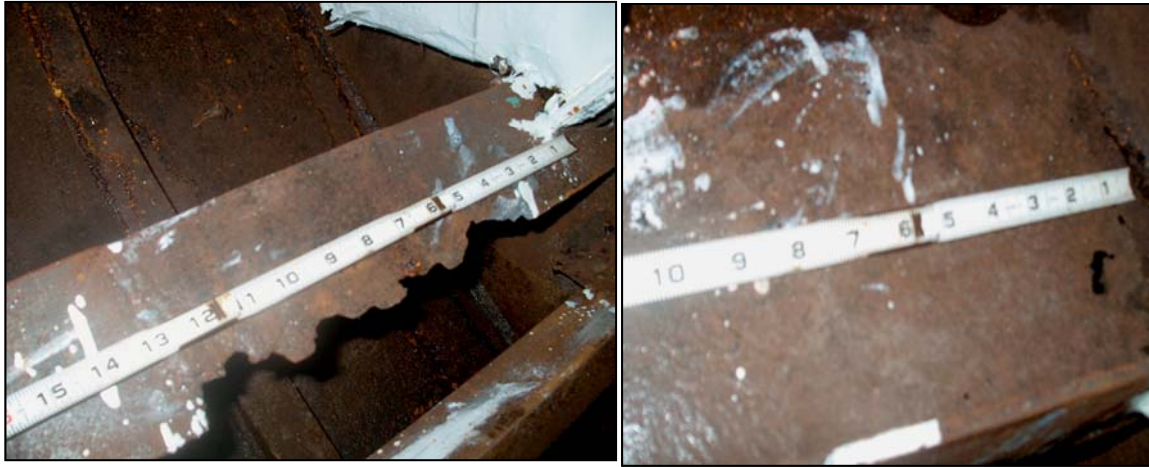
DETERIORATED 10X 4 STRINGER NO.2 PORTSIDE

SAFETY HAZARD: 1. SERIOUS - CORRECT AS SOON AS POSSIBLE 2. SERIOUS - SUSPENSION OF EQUIPMENT/SYSTEM/SPACE REQUIRED 3. SERIOUS - WAIVER OF EQUIPMENT/SYSTEM 4. SAFETY ITEM - MINOR 5. COMBUSTIBLE MATERIAL		1. MAINTENANCE ACTION COMPLETED: PARTS DRAWN FROM SUPPLY 2. MAINTENANCE ACTION COMPLETED: REQUIRED PARTS NOT DRAWN FROM SUPPLY 3. MAINTENANCE ACTION COMPLETED: NO PARTS REQUIRED 4. CANCELLED - DEFERRAL WILL BE REMOVED FROM CSMP 7. MAINTENANCE ACTION COMPLETED: 3-M CAPABILITY UTILIZED 0. NONE OF THE ABOVE, DESCRIBE IN REMARKS/DESCRIPTION SECTION		1. MANDATORY 2. ESSENTIAL 3. HIGHLY DESIRABLE 4. DESIRABLE	
DISCREPANCY DESCRIPTION: PER SEMAT UNDERWATER HULL ASSESSMENT: FWD EDUCATOR ROOM 5-51-0-Q					
STRINGERS 1& 2 STBD AND STRINGER 2 PORT ARE DETERIORATED					
RECOMMENDED REPAIRS: REPAIR ACTIVITY CUT OUT STRINGERS FROM 6" FWD OF BHD 51 TO 6" AFT OF BHD 56, REPLACE WITH 10X 4 T BEAMS APPROX 16 LFT.

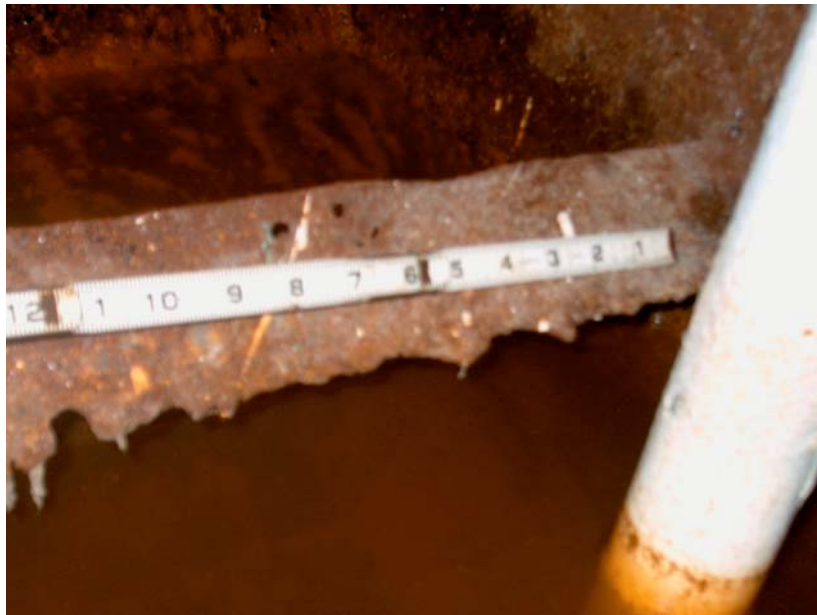
DETERIORATED 10X 4 STRINGER NO.2 STARBOARD SIDE.

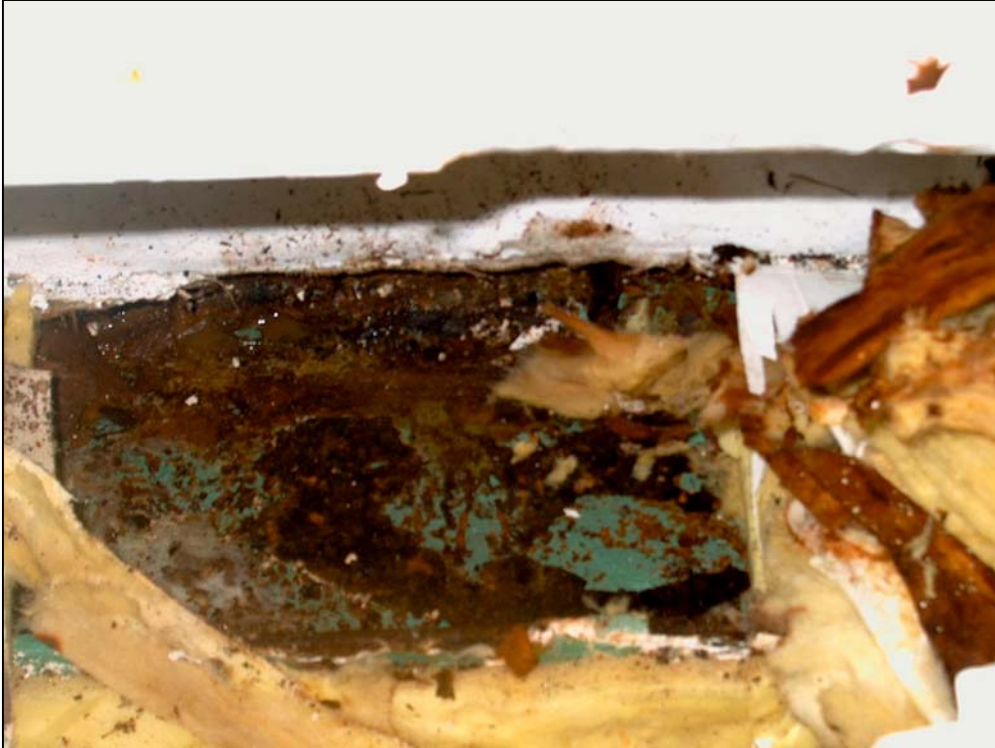
CORROSION ON STRINGER NO. 3 PORTSIDE. THE HULL INSULATION IS TRAPPING WATER AND CAUSING CORROSION. REMOVAL OF INSULATION IN THE ENTIRE SPACE IS HIGHLY RECOMMENDED.

DISCREPANCY DESCRIPTION: PER SEMAT UNDERWATER HULL ASSESSMENT: FWD EDUCTOR ROOM 5-51-0-Q					
SHELL AND BHD INSULATION IS SATURATED HIDING CORROSION					
RECOMMENDED REPAIRS: SHIPS FORCE REMOVE ALL INSULATION FROM SHELL AND BULKHEADS REMOVE SCALE, PRIME AND PAINT APPROX. 120 SQFT USING EURO- NAVY COATING REPLACEMENT OF INSULATION IS NOT RECOMMENDED					
SSPORT C221 POC: A.DAVIS (757-396-4001 EXT2130) TPOC:					
CSMP SUMMARY: SATURATED INSULATION / CORROSION				TEST# MRC 1102/1	
ROOT CAUSE/AMPLIFICATION: H1				STEP# 1 THRU 5	
SYSTEM LEVEL IMPACT:					
PART NO.	NOMENCLATURE	QTY	NSN	COST	
1					
2					
3					
4					
5					
6					
FIRST CONTACT SAVAGE	RATE LT/ CHENG	SECOND CONTACT PORT ENGINEER	RATE	PHONE	
ASSESSOR / ACT / TECH ID# F. LAROCK J. LAROCK QED SYSTEMS INC (757) 490-5047		TD	TL	LOGISTICIAN	TSP

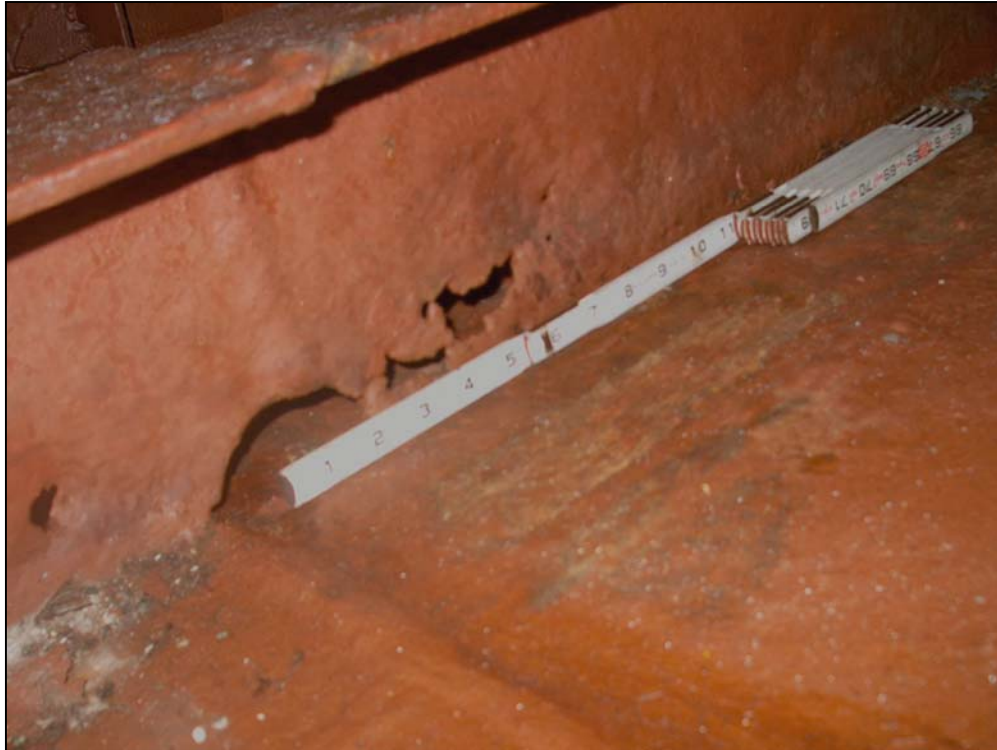
DETERIORATED WEB OF 1ST STRINGER FROM MARGIN PLATE APPROXIMATELY
1 FT AFT OF FRAME 270.

SAFETY HAZARD: 1. SERIOUS - CORRECT AS SOON AS POSSIBLE 2. SERIOUS - SUSPENSION OF EQUIPMENT/SYSTEM/SPACE REQUIRED 3. SERIOUS - WAIVER OF EQUIPMENT/SYSTEM 4. SAFETY ITEM - MINOR 5. COMBUSTIBLE MATERIAL		1. MAINTENANCE ACTION COMPLETED: PARTS DRAWN FROM SUPPLY 2. MAINTENANCE ACTION COMPLETED: REQUIRED PARTS NOT DRAWN FROM SUPPLY 3. MAINTENANCE ACTION COMPLETED: NO PARTS REQUIRED 4. CANCELLED - DEFERRAL WILL BE REMOVED FROM CSMP 7. MAINTENANCE ACTION COMPLETED: 3-M CAPABILITY UTILIZED 0. NONE OF THE ABOVE, DESCRIBE IN REMARKS/DESCRIPTION SECTION		1. MANDATORY 2. ESSENTIAL 3. HIGHLY DESIRABLE 4. DESIRABLE 4
DISCREPANCY DESCRIPTION: PER SEMAT UNDERWATER HULL ASSESSMENT: MER 5-250-0-E PORT SIDE WEB OF STRINGER 7 (1 ST STRINGER FROM MARGIN PLATE) IS DETERIORATED AT WELD SEAM 1FT AFT OF FRAME 270.				
RECOMMENDED REPAIRS: CROP OUT AND REPLACE APPROX 2LF WEB USING .375 OS. PRIME AND PAINT TO MATCH

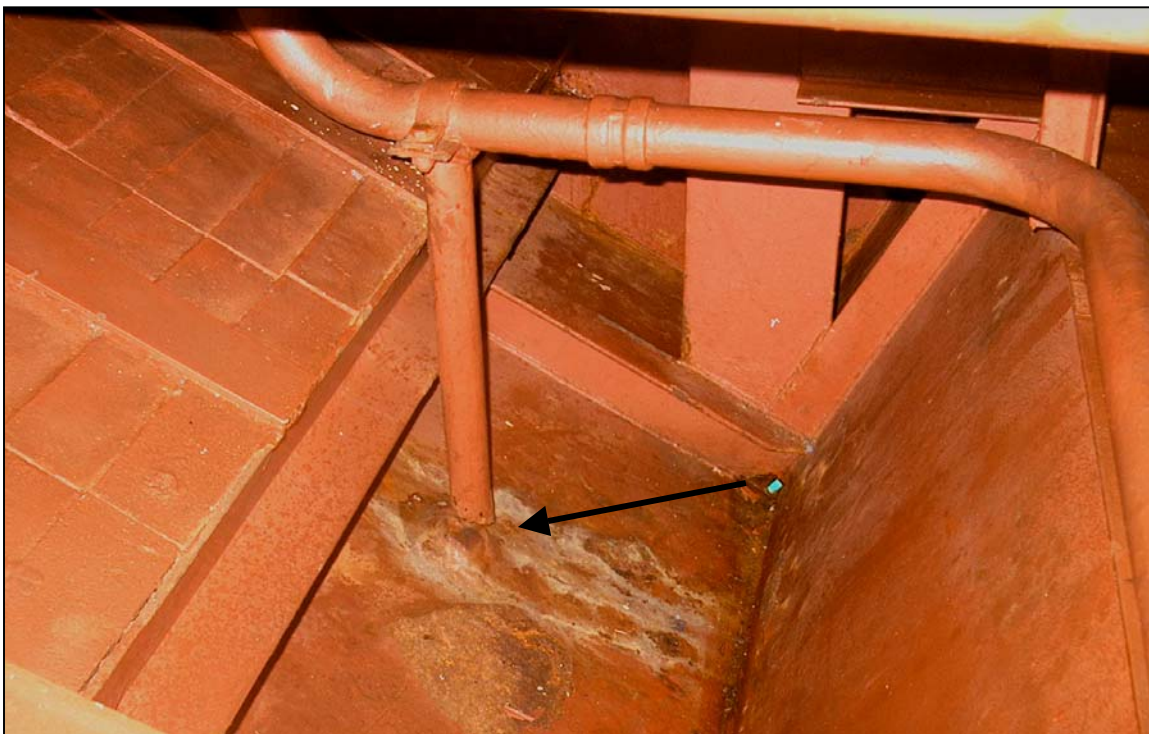
CORROSION ON SHELL PLATE FORWARD OF FRAME 264. ARROW INDICATES
DETERIORATED PIPE HANGER SUPPORT.

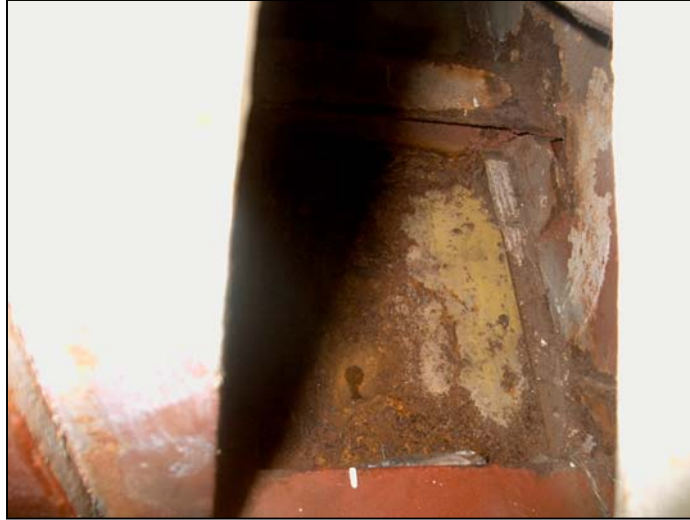
PORT SIDE SHELL BETWEEN LUBE OIL TANK AND FRAME 270.
HULL INSULATION IS CREATING AND HIDING CORROSION.

SAFETY HAZARD: 1. SERIOUS - CORRECT AS SOON AS POSSIBLE 2. SERIOUS - SUSPENSION OF EQUIPMENT/SYSTEM/SPACE REQUIRED 3. SERIOUS - WAIVER OF EQUIPMENT/SYSTEM 4. SAFETY ITEM - MINOR 5. COMBUSTIBLE MATERIAL		1. MAINTENANCE ACTION COMPLETED: PARTS DRAWN FROM SUPPLY 2. MAINTENANCE ACTION COMPLETED: REQUIRED PARTS NOT DRAWN FROM SUPPLY 3. MAINTENANCE ACTION COMPLETED: NO PARTS REQUIRED 4. CANCELLED - DEFERRAL WILL BE REMOVED FROM CSMP 7. MAINTENANCE ACTION COMPLETED: 3-M CAPABILITY UTILIZED 0. NONE OF THE ABOVE, DESCRIBE IN REMARKS/DESCRIPTION SECTION			1. MANDATORY 2. ESSENTIAL 3. HIGHLY DESIRABLE 4. DESIRABLE
DISCREPANCY DESCRIPTION: PER SEMAT UNDERWATER HULL ASSESSMENT: MER 5-250-0-E PORT AND STBD BETWEEN BHD 250 AND FRAME 278. HULL INSULATION IS TRAPPING WATER AND CAUSING CORROSION.					
RECOMMENDED REPAIRS: SHIPS FORCE REMOVE HULL INSULATION PORT& STBD FROM DECK LEVEL TO APPROX 4FT UP REMOVE CORROSION, PRIME AND PAINT USING EURO NAVY COATING. APPROX 120 SQFT REPLACEMENT OF INSULATION IS NOT RECOMMENDED.

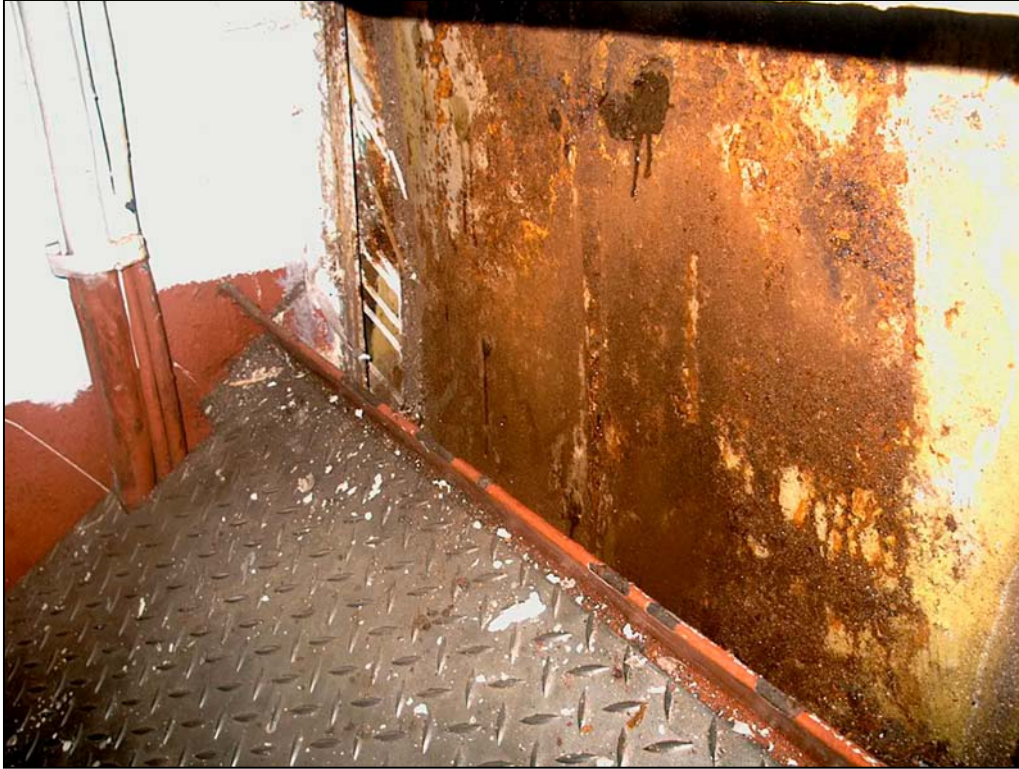
CORROSION ON THE SHELL AFT OF FRAME 270 STARBOARD.
HULL INSULATION IS HIDING AND CREATING CORROSION.

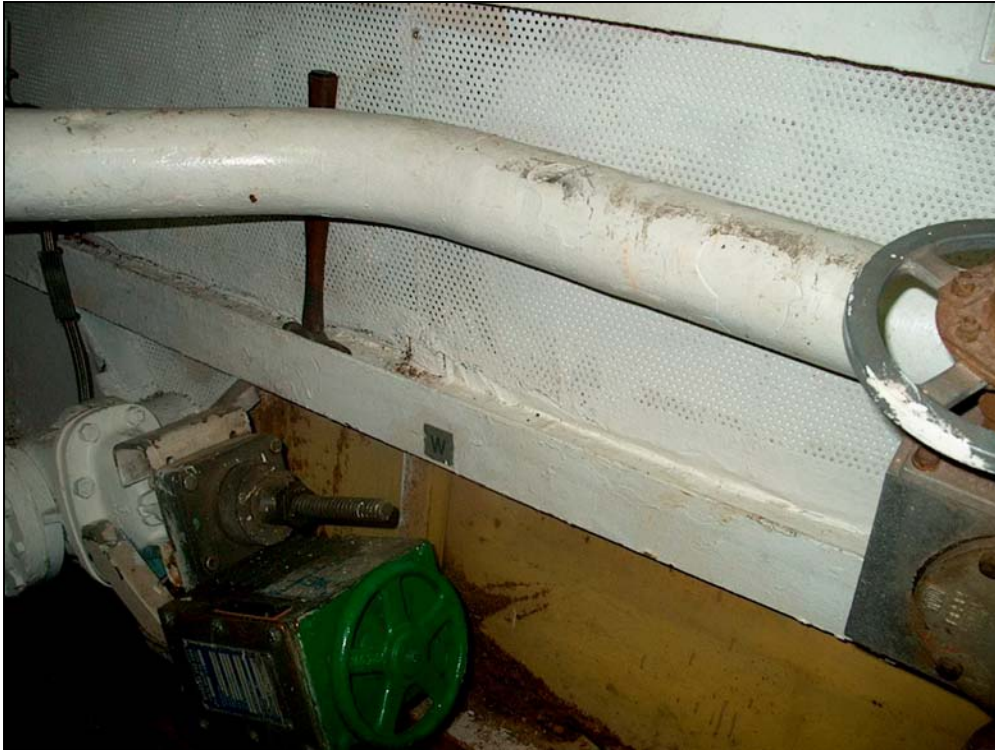
PORT SIDE OUTBOARD OF NO.1 HPAC. REMOVAL OF THE HULL INSULATION
REVEALED HEAVY SCALING ON THE SHELL.

SAFETY HAZARD: 1. SERIOUS - CORRECT AS SOON AS POSSIBLE 2. SERIOUS - SUSPENSION OF EQUIPMENT/SYSTEM/SPACE REQUIRED 3. SERIOUS - WAIVER OF EQUIPMENT/SYSTEM 4. SAFETY ITEM - MINOR 5. COMBUSTIBLE MATERIAL		1. MAINTENANCE ACTION COMPLETED: PARTS DRAWN FROM SUPPLY 2. MAINTENANCE ACTION COMPLETED: REQUIRED PARTS NOT DRAWN FROM SUPPLY 3. MAINTENANCE ACTION COMPLETED: NO PARTS REQUIRED 4. CANCELLED - DEFERRAL WILL BE REMOVED FROM CSMP 7. MAINTENANCE ACTION COMPLETED: 3-M CAPABILITY UTILIZED 0. NONE OF THE ABOVE, DESCRIBE IN REMARKS/DESCRIPTION SECTION		1. MANDATORY 2. ESSENTIAL 3. HIGHLY DESIRABLE 4. DESIRABLE 4	
DISCREPANCY DESCRIPTION: PER SEMAT UNDERWATER HULL ASSESSMENT: AMR 2 (5-212-0-E) PORT AND STBD SHELL					
BETWEEN BHD 212 AND FRAME 228, FROM STRINGER S 11 TO 13. HULL INSULATION IS SATURATED CAUSING					
CORROSION ON THE SHELL.					
RECOMMENDED REPAIRS: SHIPS FORCE REMOVE HULL INSULATION, POWER CLEAN AREA TO BARE METAL, PRIME AND PAINT. REPLACEMENT OF INSULATION IS NOT RECOMMENDED. APPROX 120 SQFT TOTAL PORT& STBD.

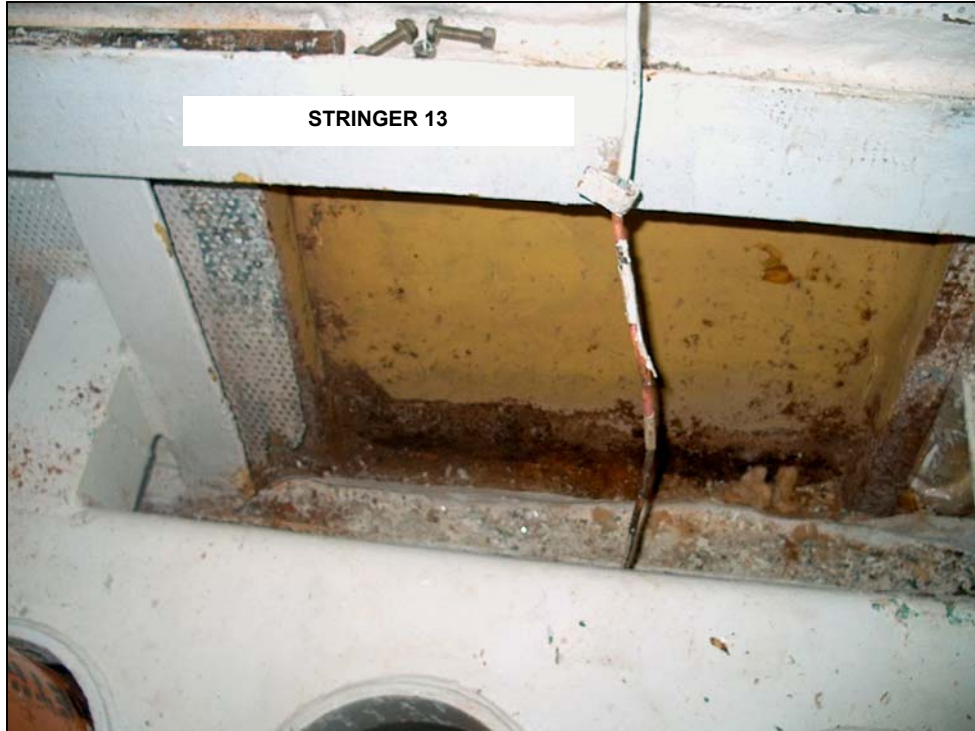
STARBOARD SIDE UPPER LEVEL BETWEEN FRAMES 212 AND 220
REMOVAL OF HULL INSULATION REVEALED SURFACE SCALING.

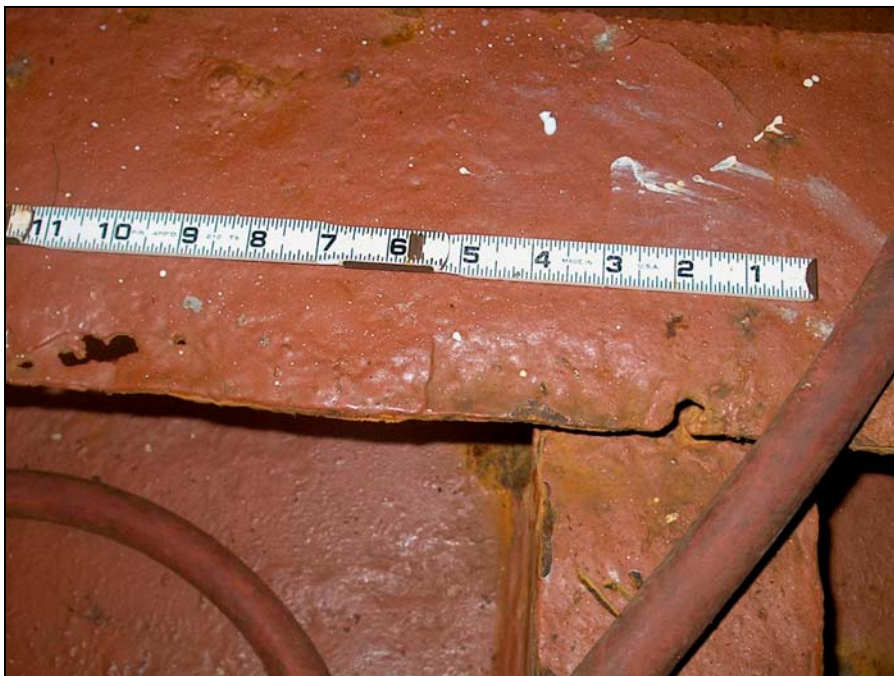
CSMP SUMMARY: FLANGE OF STRINGER 6 STBD IS HOLED				TEST# MRC 1102/1	
ROOT CAUSE/AMPLIFICATION: H1				STEP# 1 THRU 5	
SYSTEM LEVEL IMPACT:					
PART NO.	NOMENCLATURE		QTY	NSN	COST
1					
2					
3					
4					
5					
6					
FIRST CONTACT SAVAGE	RATE LT/ CHENG	SECOND CONTACT PORT ENGINEER	RATE	PHONE	
ASSESSOR / ACT / TECH ID# F. LAROCK J. LAROCK QED SYSTEMS INC (757) 490-5047			TD	TL	LOGISTICIAN TSP

DETERIORATED FLANGE OF STRINGER 6 APPROXIMATELY 1FT FORWARD OF
FRAME 220.

SAFETY HAZARD: 1. SERIOUS - CORRECT AS SOON AS POSSIBLE 2. SERIOUS - SUSPENSION OF EQUIPMENT/SYSTEM/SPACE REQUIRED 3. SERIOUS - WAIVER OF EQUIPMENT/SYSTEM 4. SAFETY ITEM - MINOR 5. COMBUSTIBLE MATERIAL		1. MAINTENANCE ACTION COMPLETED: PARTS DRAWN FROM SUPPLY 2. MAINTENANCE ACTION COMPLETED: REQUIRED PARTS NOT DRAWN FROM SUPPLY 3. MAINTENANCE ACTION COMPLETED: NO PARTS REQUIRED 4. CANCELLED - DEFERRAL WILL BE REMOVED FROM CSMP 7. MAINTENANCE ACTION COMPLETED: 3-M CAPABILITY UTILIZED 0. NONE OF THE ABOVE, DESCRIBE IN REMARKS/DESCRIPTION SECTION		1. MANDATORY 2. ESSENTIAL 3. HIGHLY DESIRABLE 4. DESIRABLE 4	
DISCREPANCY DESCRIPTION: PER SEMAT UNDERWATER HULL ASSESSMENT: AMR 2 5-212-0-E FLANGE OF STRINGER 6 STBD					
IS DETERIORATED FWD OF FRAME 220 (7X 6 3/4) T					
RECOMMENDED REPAIRS: CUT OUT AND REPLACE APPROX. 30" OF FLANGE USING .375 OS PRIME AND PAINT.					
SSPORT C221 POC: A.DAVIS (757-396-4001 EXT 2130) TPOC:

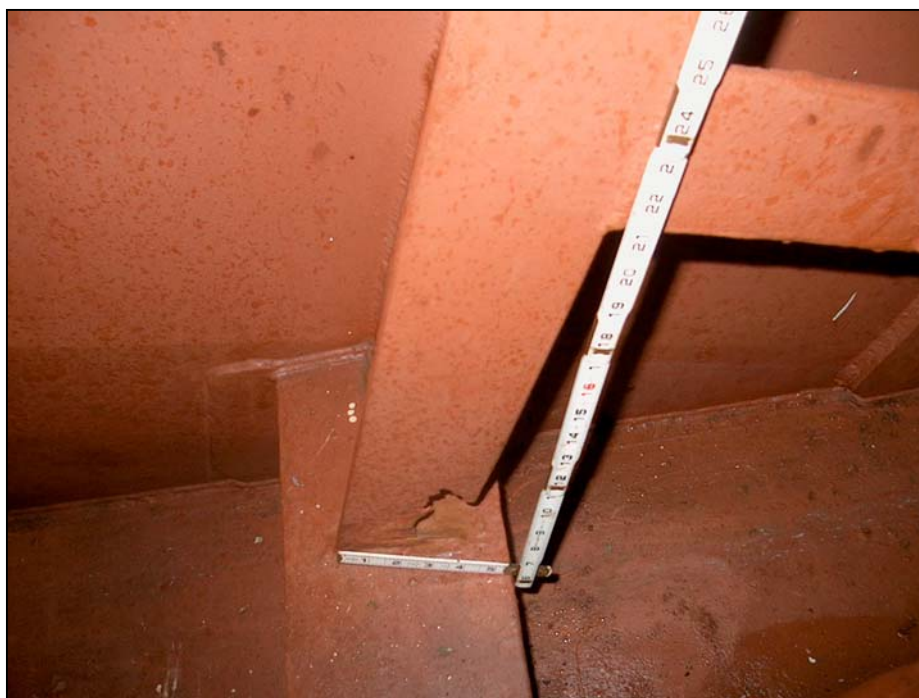
CSMP SUMMARY: 3 RD PORT BHD (250) STIFFENER IS DETERIORATED				TEST# MRC 1102/1	
ROOT CAUSE/AMPLIFICATION: H1				STEP# 1 THRU 5	
SYSTEM LEVEL IMPACT:					
PART NO.	NOMENCLATURE		QTY	NSN	COST
1					
2					
3					
4					
5					
6					
FIRST CONTACT SAVAGE	RATE LT/ CHENG	SECOND CONTACT PORT ENGINEER	RATE	PHONE	
ASSESSOR / ACT / TECH ID# F. LAROCK J. LAROCK QED SYSTEMS INC (757) 490-5047			TD	TL	LOGISTICIAN TSP

DETERIORATED FLANGE OF BULKHEAD STIFFENER NO.3 PORT SIDE
LOOKING AFT AT BULKHEAD 250.

SAFETY HAZARD: 1. SERIOUS - CORRECT AS SOON AS POSSIBLE 2. SERIOUS - SUSPENSION OF EQUIPMENT/SYSTEM/SPACE REQUIRED 3. SERIOUS - WAIVER OF EQUIPMENT/SYSTEM 4. SAFETY ITEM - MINOR 5. COMBUSTIBLE MATERIAL		1. MAINTENANCE ACTION COMPLETED: PARTS DRAWN FROM SUPPLY 2. MAINTENANCE ACTION COMPLETED: REQUIRED PARTS NOT DRAWN FROM SUPPLY 3. MAINTENANCE ACTION COMPLETED: NO PARTS REQUIRED 4. CANCELLED - DEFERRAL WILL BE REMOVED FROM CSMP 7. MAINTENANCE ACTION COMPLETED: 3-M CAPABILITY UTILIZED 0. NONE OF THE ABOVE, DESCRIBE IN REMARKS/DESCRIPTION SECTION		1. MANDATORY 2. ESSENTIAL 3. HIGHLY DESIRABLE 4. DESIRABLE 4	
DISCREPANCY DESCRIPTION: PER SEMAT UNDERWATER HULL ASSESSMENT: AMR 2 5-212-0-E THE LOWER 2 FT OF THE 3 RD					
VERTICAL BHD (250)5X4 STIFFENER PORT SIDE IS DETERIORATED					
RECOMMENDED REPAIRS: CUT OUT AND REPLACE THE LOWER 2FT OF STIFFENER, PRIME AND PAINT TO MATCH					
SSPORT C221 POC: A.DAVIS (757-396-4001 EXT 2130) TPOC:

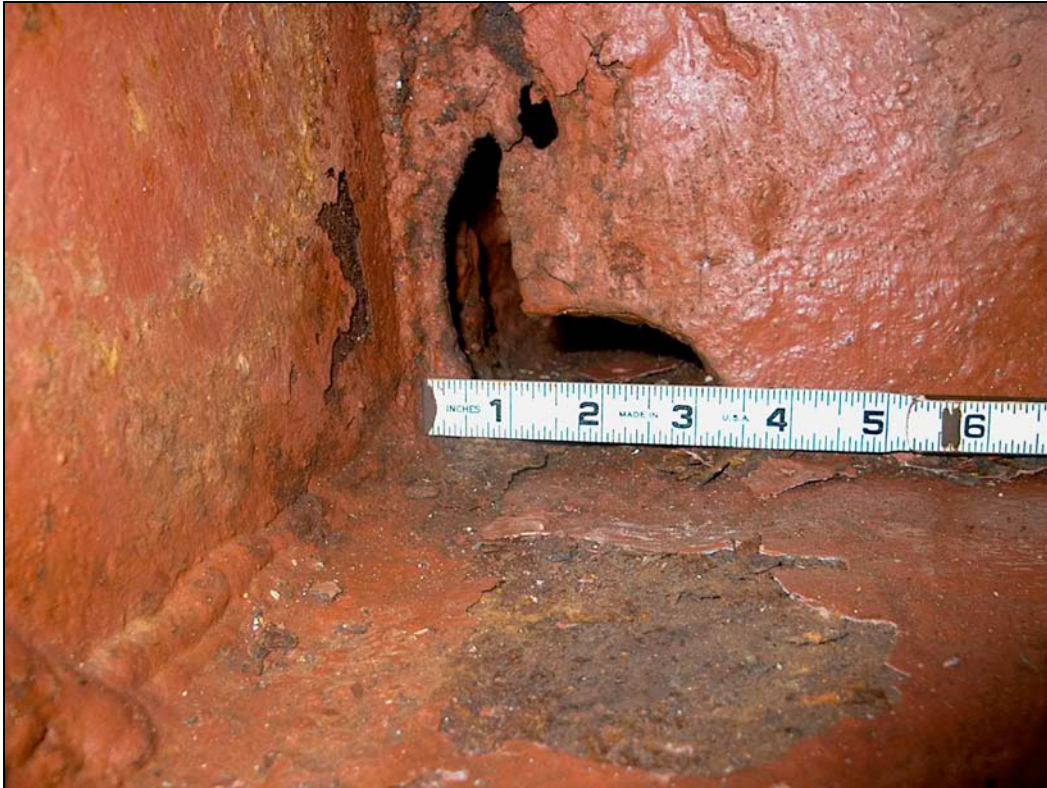
CSMP SUMMARY: PORT STRINGER 6 IS HOLED				TEST# MRC 1102/1	
ROOT CAUSE/AMPLIFICATION: H1				STEP# 1 THRU 5	
SYSTEM LEVEL IMPACT:					
PART NO.	NOMENCLATURE	QTY	NSN	COST	
1					
2					
3					
4					
5					
6					
FIRST CONTACT SAVAGE	RATE LT/ CHENG	SECOND CONTACT PORT ENGINEER	RATE	PHONE	
ASSESSOR / ACT / TECH ID# F. LAROCK J. LAROCK QED SYSTEMS INC (757) 490-5047		TD	TL	LOGISTICIAN	TSP

DETERIORATED STRINGER NO. 6 AT BULKHEAD (180) PORT SIDE. U/T READINGS OF THE BULKHEAD REVEALED NO SIGNIFICANT METAL LOSS.

SAFETY HAZARD: 1. SERIOUS - CORRECT AS SOON AS POSSIBLE 2. SERIOUS - SUSPENSION OF EQUIPMENT/SYSTEM/SPACE REQUIRED 3. SERIOUS - WAIVER OF EQUIPMENT/SYSTEM 4. SAFETY ITEM - MINOR 5. COMBUSTIBLE MATERIAL		1. MAINTENANCE ACTION COMPLETED: PARTS DRAWN FROM SUPPLY 2. MAINTENANCE ACTION COMPLETED: REQUIRED PARTS NOT DRAWN FROM SUPPLY 3. MAINTENANCE ACTION COMPLETED: NO PARTS REQUIRED 4. CANCELLED - DEFERRAL WILL BE REMOVED FROM CSMP 7. MAINTENANCE ACTION COMPLETED: 3-M CAPABILITY UTILIZED 0. NONE OF THE ABOVE, DESCRIBE IN REMARKS/DESCRIPTION SECTION		1. MANDATORY 2. ESSENTIAL 3. HIGHLY DESIRABLE 4. DESIRABLE	
DISCREPANCY DESCRIPTION: PER SEMAT UNDERWATER HULL ASSESSMENT: AMR 1 5-180-0-E WEB OF STRINGER 6 PORT SIDE					
IS HOLED AT BHD 180					
RECOMMENDED REPAIRS: CUT OUT AND REPLACE APPROX 1 SQFT OF WEB USING .375 OS. PRIME AND PAINT TO MATCH SURROUNDING AREA.					
SSPORT C221 POC: A.DAVIS (757-396-4001 EXT) TPOC:

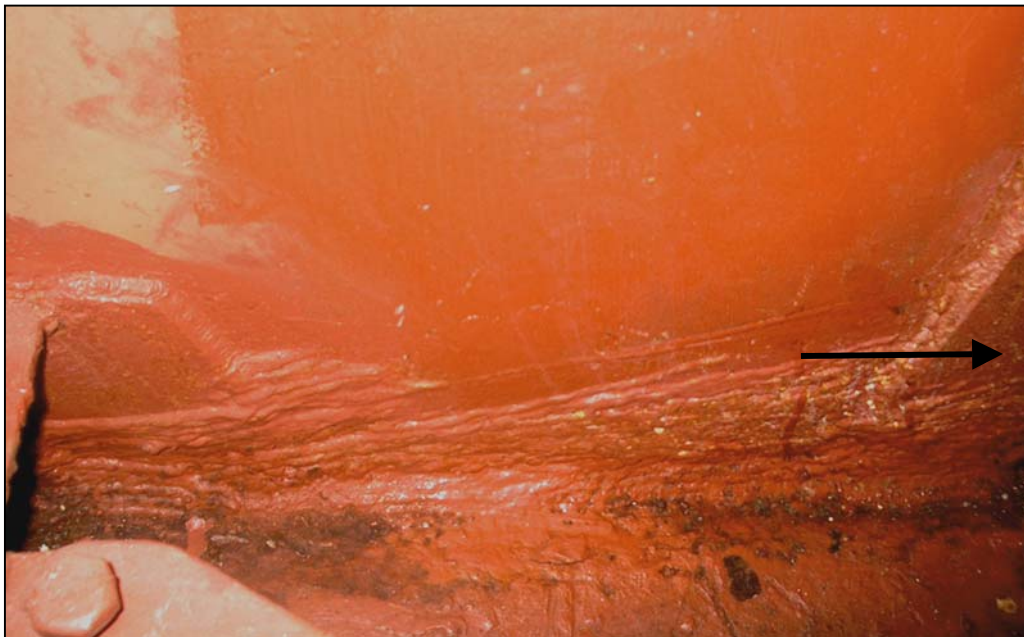
CLAD WELD REPAIRS ON BULKHEAD (180) PORT SIDE. ARROW INDICATES LOCATION OF STRINGER 6.

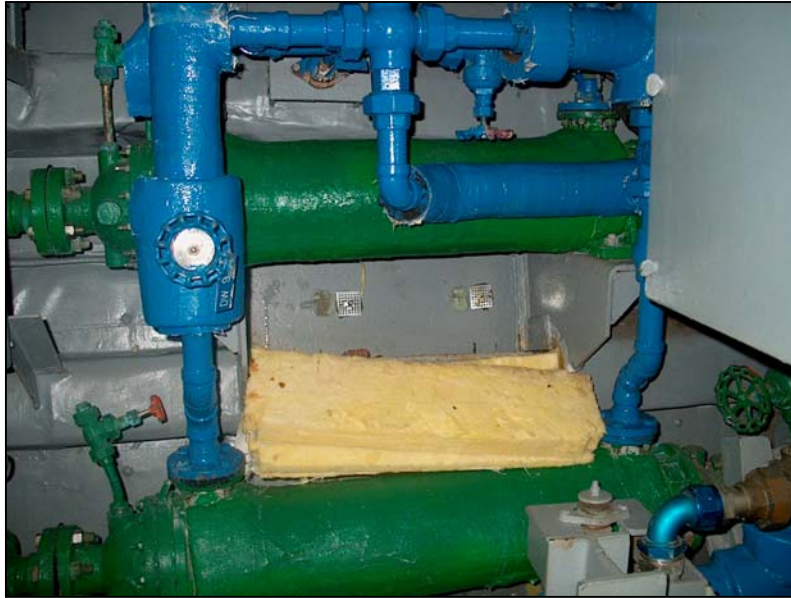
SSPORT C221 POC: A.DAVIS (757-396-4001 EXT 2130) TPOC:					
CSMP SUMMARY: DETERIORATED INTERCOSTALS, SATURATED INSULATION				TEST# MRC 1102/1	
ROOT CAUSE/AMPLIFICATION: H1				STEP# 1 THRU 5	
SYSTEM LEVEL IMPACT:					
PART NO.	NOMENCLATURE		QTY	NSN	COST
1					
2					
3					
4					
5					
6					
FIRST CONTACT SAVAGE	RATE LT/ CHENG	SECOND CONTACT PORT ENGINEER	RATE	PHONE	
ASSESSOR / ACT / TECH ID# F. LAROCK J. LAROCK QED SYSTEMS INC (757) 490-5047			TD	TL	LOGISTICIAN TSP

STARBOARD SHELL. REMOVAL OF HULL INSULATION AND USE OF AN ANTI- SWEAT COATING IS HIGHLY RECOMMENDED. THIS AREA IS A CLASS WIDE PROBLEM.

SAFETY HAZARD: 1. SERIOUS - CORRECT AS SOON AS POSSIBLE 2. SERIOUS - SUSPENSION OF EQUIPMENT/SYSTEM/SPACE REQUIRED 3. SERIOUS - WAIVER OF EQUIPMENT/SYSTEM 4. SAFETY ITEM - MINOR 5. COMBUSTIBLE MATERIAL		1. MAINTENANCE ACTION COMPLETED: PARTS DRAWN FROM SUPPLY 2. MAINTENANCE ACTION COMPLETED: REQUIRED PARTS NOT DRAWN FROM SUPPLY 3. MAINTENANCE ACTION COMPLETED: NO PARTS REQUIRED 4. CANCELLED - DEFERRAL WILL BE REMOVED FROM CSMP 7. MAINTENANCE ACTION COMPLETED: 3-M CAPABILITY UTILIZED 0. NONE OF THE ABOVE, DESCRIBE IN REMARKS/DESCRIPTION SECTION		1. MANDATORY 2. ESSENTIAL 3. HIGHLY DESIRABLE 4. DESIRABLE 4	
DISCREPANCY DESCRIPTION: PER SEMAT UNDERWATER HULL ASSESSMENT: SONAR COOLING EQUIPMENT ROOM 4-48-1-Q					
CENTER AND AFT 2X3 INTERCOSTALS ARE DETERIORATED. HULL INSULATION IS SATURATED.					
RECOMMENDED REPAIRS: CUT OUT AND REPLACE BOTH INTERCOSTALS APPROX. 12 LFT. RECOMMEND REMOVAL OF HULL INSULATION, CLEAN PRIME AND PAINT USING AN ANTI SWEAT COATING. APPROX 64 SQFT.

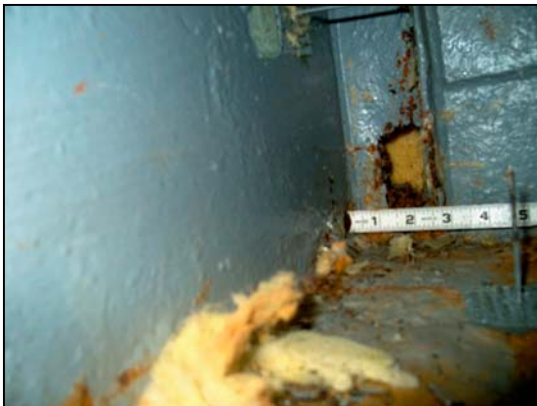
HOLED 3"X 2 "INTERCOSTAL APPROXIMATELY
2FEET FORWARD OF BULKHEAD (55).

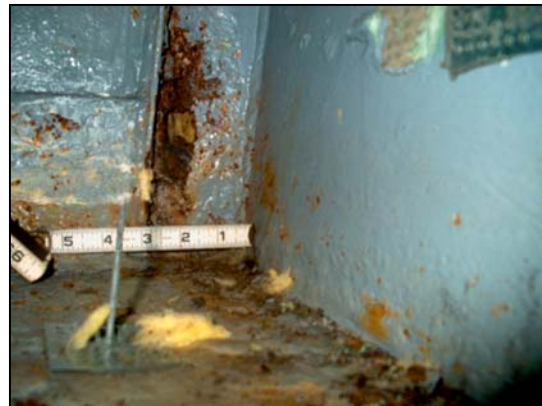
HOLED 3"X 2 "INTERCOSTAL APPROXIMATELY
2FEET AFT OF BULKHEAD (48).

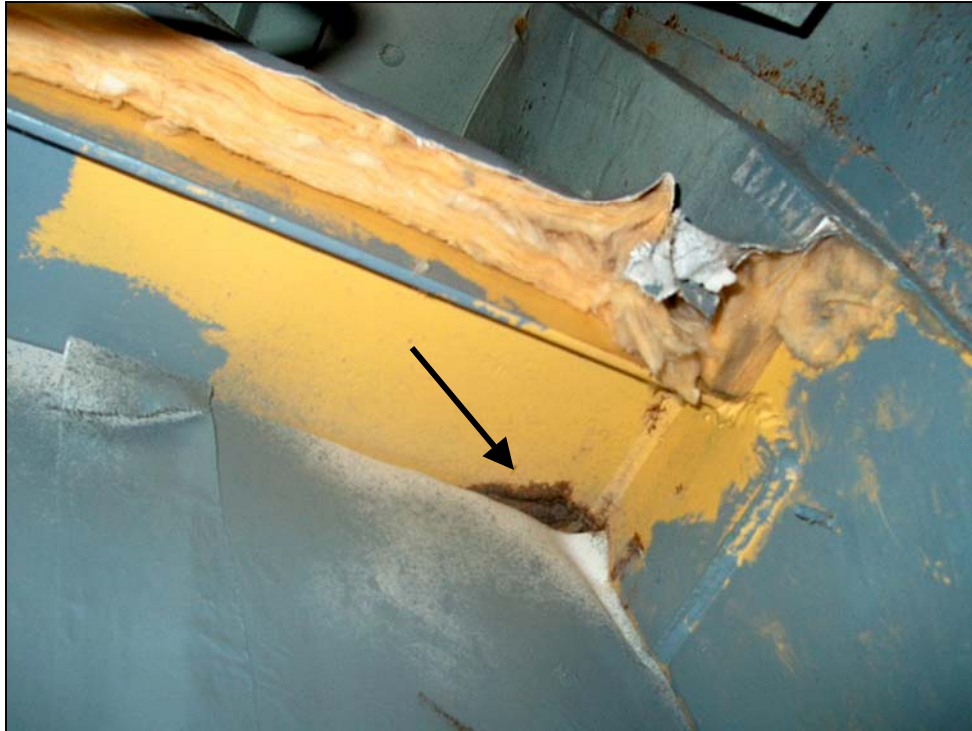
HOLED 4TH STRINGER FROM THE DECK AT BULKHEAD (55). THE NATURE OF THE EQUIPMENT AND THE HULL INSULATION CREATES THIS PROBLEM.

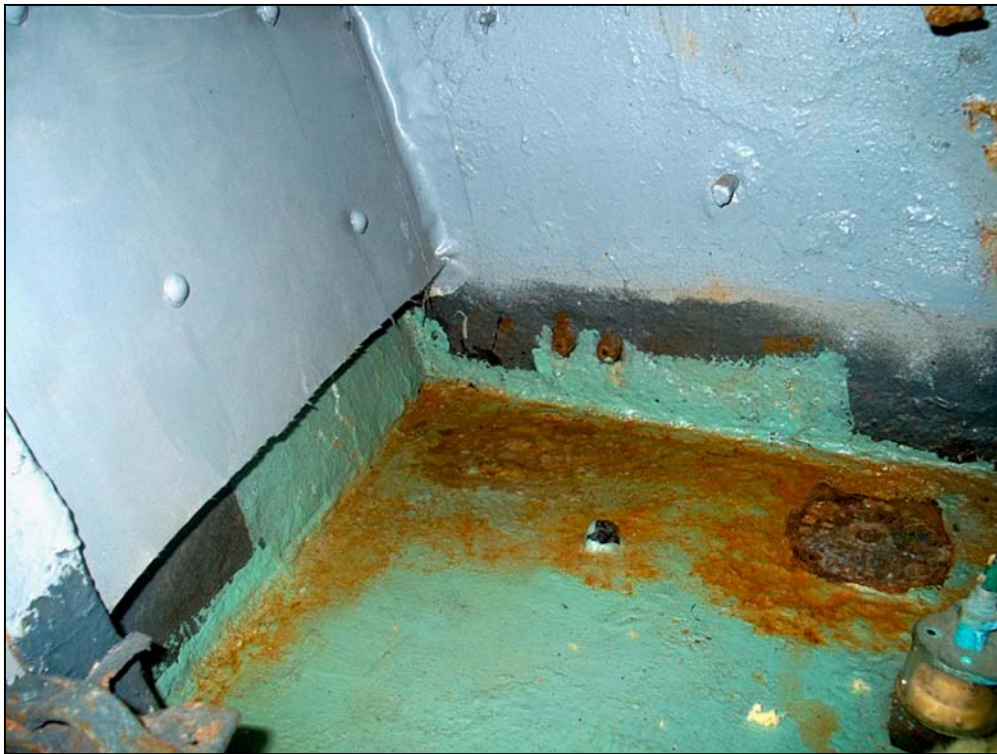
CORROSION ON THE DECK AT BULKHEAD (55). LOCATION OF THE DECK DRAIN IS THE MAIN CAUSE OF CORROSION.

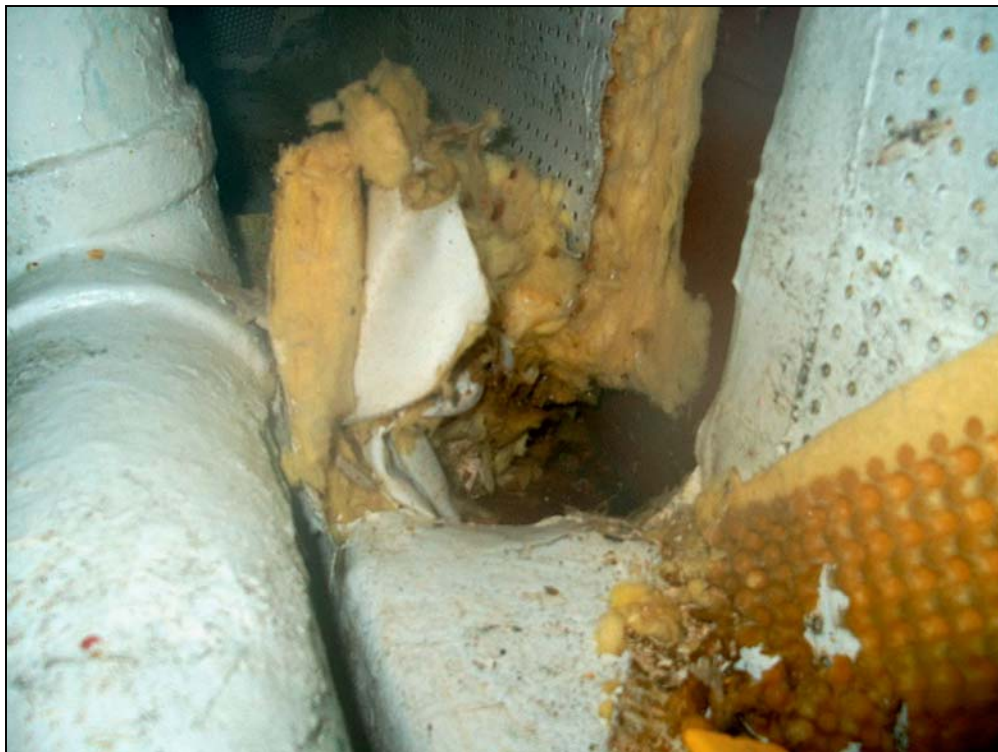
SATURATED HULL INSULATION OUTBOARD OF A/C PLANT.

SSPORT C221 POC: A.DAVIS (757-396-4001 EXT 2130) TPOC:					
CSMP SUMMARY: INSULATION SATURATED				TEST# MRC 1102/1	
ROOT CAUSE/AMPLIFICATION: H1				STEP# 1 THRU 5	
SYSTEM LEVEL IMPACT:					
PART NO.	NOMENCLATURE	QTY	NSN	COST	
1					
2					
3					
4					
5					
6					
FIRST CONTACT SAVAGE	RATE LT/ CHENG	SECOND CONTACT PORT ENGINEER	RATE	PHONE	
ASSESSOR / ACT / TECH ID# F. LAROCK J. LAROCK QED SYSTEMS INC (757) 490-5047		TD	TL	LOGISTICIAN	TSP

SAFETY HAZARD: 1. SERIOUS - CORRECT AS SOON AS POSSIBLE 2. SERIOUS - SUSPENSION OF EQUIPMENT/SYSTEM/SPACE REQUIRED 3. SERIOUS - WAIVER OF EQUIPMENT/SYSTEM 4. SAFETY ITEM - MINOR 5. COMBUSTIBLE MATERIAL		1. MAINTENANCE ACTION COMPLETED: PARTS DRAWN FROM SUPPLY 2. MAINTENANCE ACTION COMPLETED: REQUIRED PARTS NOT DRAWN FROM SUPPLY 3. MAINTENANCE ACTION COMPLETED: NO PARTS REQUIRED 4. CANCELLED - DEFERRAL WILL BE REMOVED FROM CSMP 7. MAINTENANCE ACTION COMPLETED: 3-M CAPABILITY UTILIZED 0. NONE OF THE ABOVE, DESCRIBE IN REMARKS/DESCRIPTION SECTION		1. MANDATORY 2. ESSENTIAL 3. HIGHLY DESIRABLE 4. DESIRABLE	
DISCREPANCY DESCRIPTION: PER SEMAT UNDERWATER HULL ASSESSMENT: CLEANING GEAR LOCKER 4-140-1-L					
SHELL INSULATION IS DETERIORATED AND WATER SOAKED					
RECOMMENDED REPAIRS: REMOVE INSULATION FROM STRINGER 14 TO DECK REMOVE SCALING, PRIME,PAINT ,REPLACE INSULATION APPROX 30 SQFT. FABRICATE STAINLESS STEEL PROTECTIVE COVER FOR INSULATION

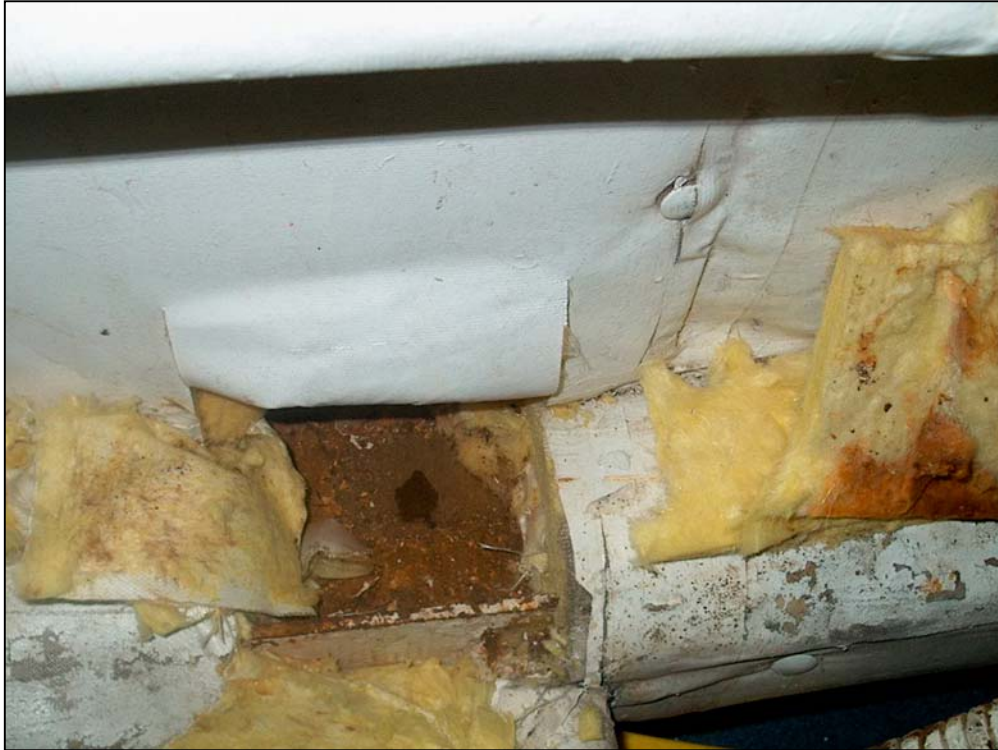
WET INSULATION AND CORROSION ON SHELL AT STRINGER 13 OUTBOARD OF SINK.
